# **INDOOR AIR QUALITY ASSESSMENT**

**L.D. Batchelder Elementary School  
2 Peabody Street  
North Reading, Massachusetts**

Prepared by:  
Massachusetts Department of Public Health  
Bureau of Environmental Health Assessment  
March, 2001

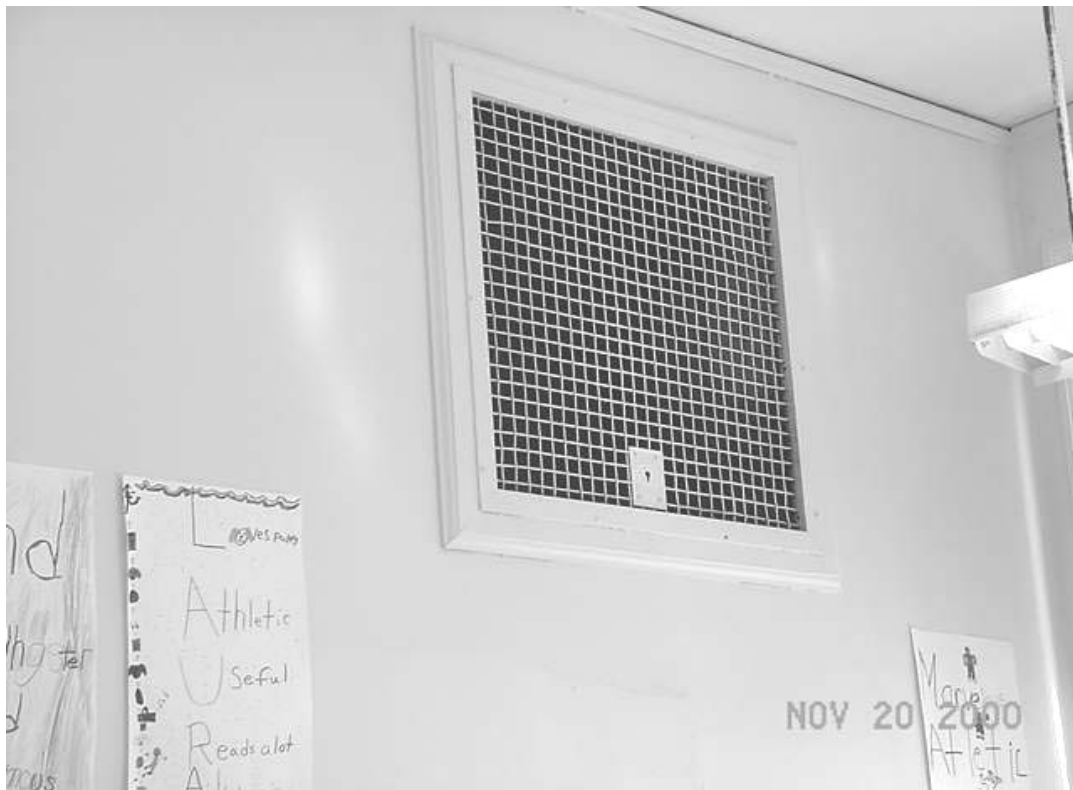
**Picture 1**

The 1917 wing does not have an operating mechanical system. The original ventilation system appears to have been intentionally abandoned. Originally, ventilation was provided by a series of louvered vents. Each classroom has an approximately 3' x 3' grated air vent in the center of an interior wall near the ceiling (see Picture 1) which is connected by a ventilation shaft to a vault-like room in the basement (see Picture 2). A

**Natural/Gravity Supply Vent**

3. Examine the feasibility of restoring the original gravity feed ventilation system. This may entail repair or replacement of heating elements located in ventilation shafts; repair of broken or missing warm air and cool air pulley chain/louver door systems to provide ventilation in this building as designed; repair of the hinged-pulley system and/or installation of openable windows in basement area to provide fresh air to classrooms. If restoration is not an option, consideration should be given to installing a mechanical ventilation system in the original building.

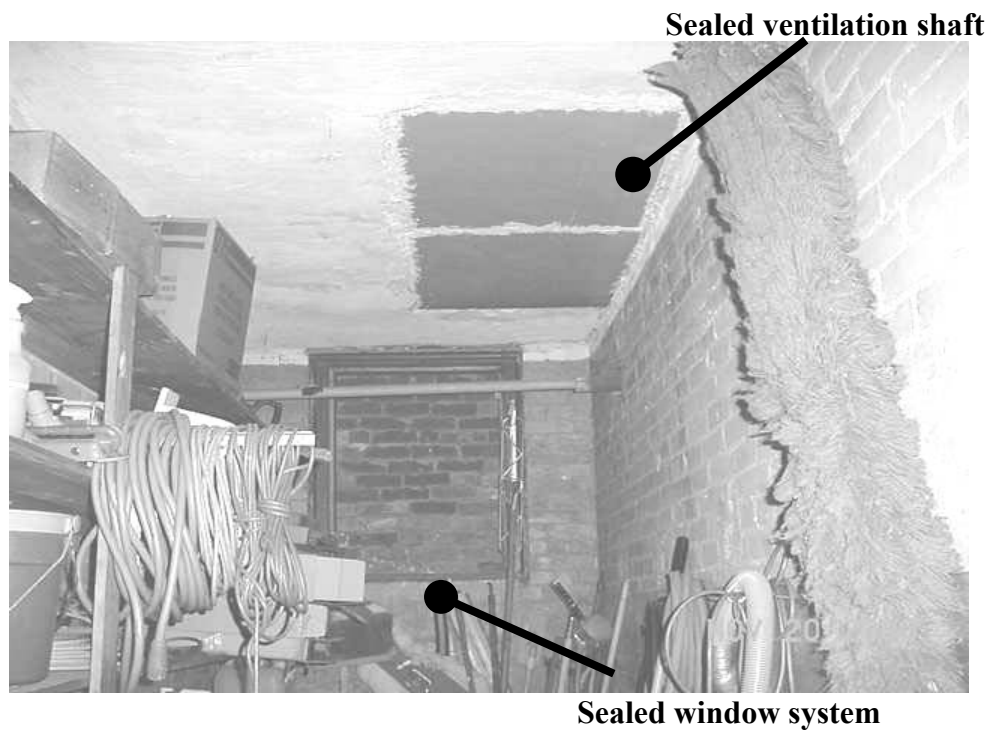
**Picture 2**

**Former Air-Mixing Vault in Basement**

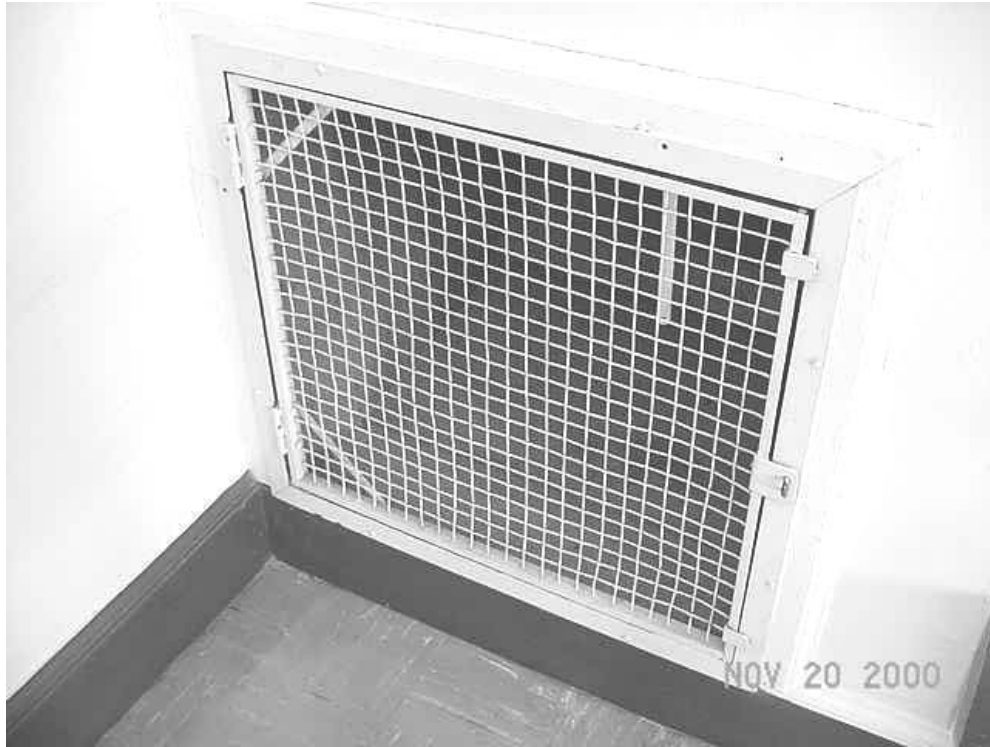
**Picture 3**

corresponding 3' x 3' vent exists in each room (see Picture 3) near the classroom doorway that is connected to an exhaust ventilation shaft that runs from the roof to the basement. Classrooms were constructed around these shafts to provide exhaust ventilation.

**Natural/Gravity Exhaust Vent**

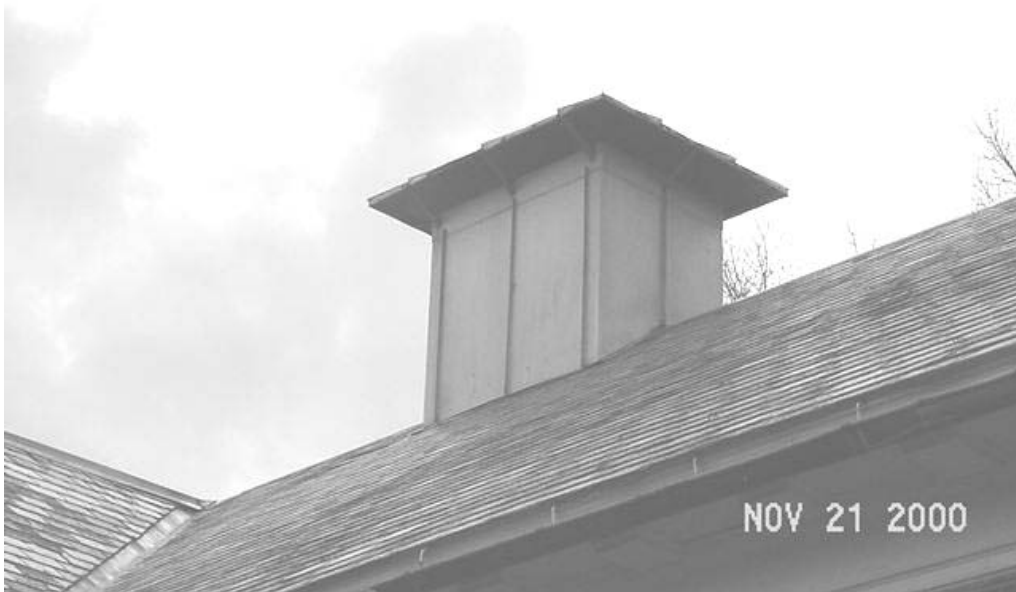
**Picture 4**

Exhaust ventilation was originally provided by a natural/gravity system. Each classroom is constructed around a ventilation airshaft that terminates on the roof in a series of chimney-like structures, which have been abandoned (see Pictures 4). Above each vent of a classroom is a radiator-like heating element. The heating element would heat air, which would rise and exit the building through the rooftop vents. As the heated air rises classroom air is drawn into the vent. A number of these vents were sealed throughout the building. Without a functional exhaust system, normally occurring environmental pollutants can build up. Care should also be taken to ensure ventilation shafts are rendered airtight in classrooms and at the roof to prevent the egress of dirt, dust and drafts into occupied areas.

**Sealed Chimney on Roof**

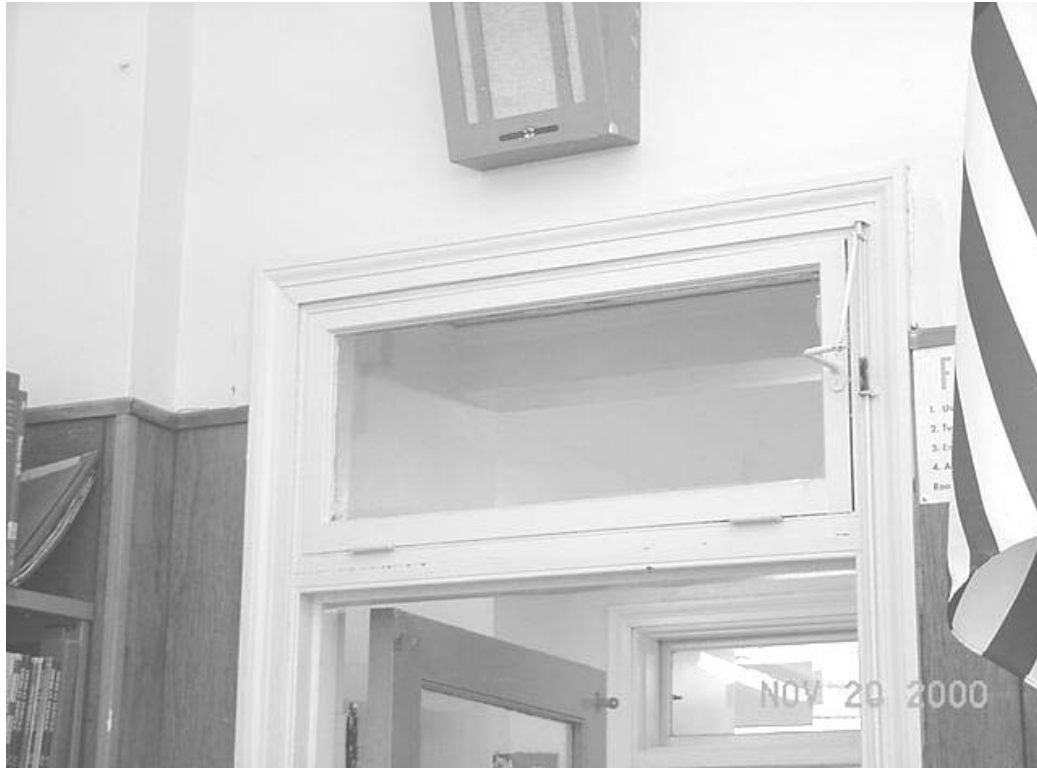
**Picture 5**

addition, the building has hinged windows located above the hallway doors. This hinged window (called a transom) (see Picture 5) enables classroom occupants to close the hallway door while maintaining a pathway for airflow. The design allows for airflow to enter an open window, pass through a classroom and subsequently pass through the open transom. Airflow then enters the hallway, passing through the opposing open classroom transom, into the opposing classroom and finally exits the building on the leeward side (opposite the windward side) (see Figure 2). With all windows and transoms open, airflow can be maintained in a building regardless of the direction of the wind. This system fails if the windows or transoms are closed (see Figure 3). Transoms are opened using a rod/hinge system. Most transoms in these wings are inoperable. The doorframes appear to have been painted, resulting in the repeated coating of the transom control rods.

**Transoms Located above Classroom Doors**

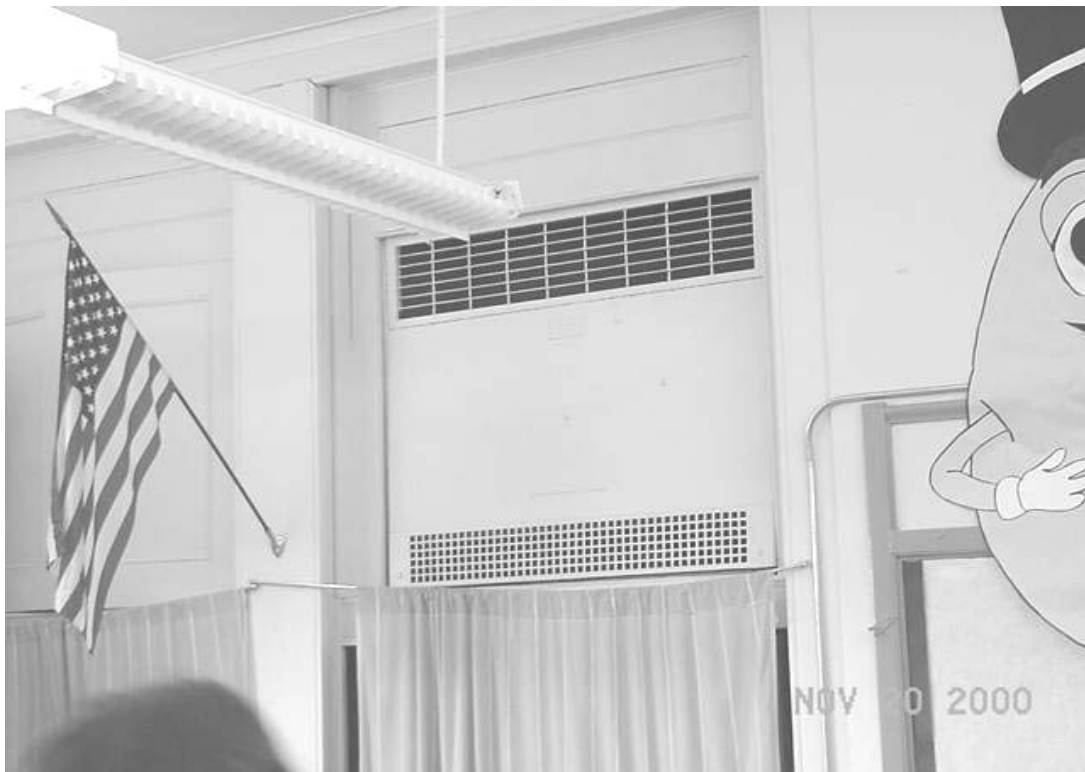
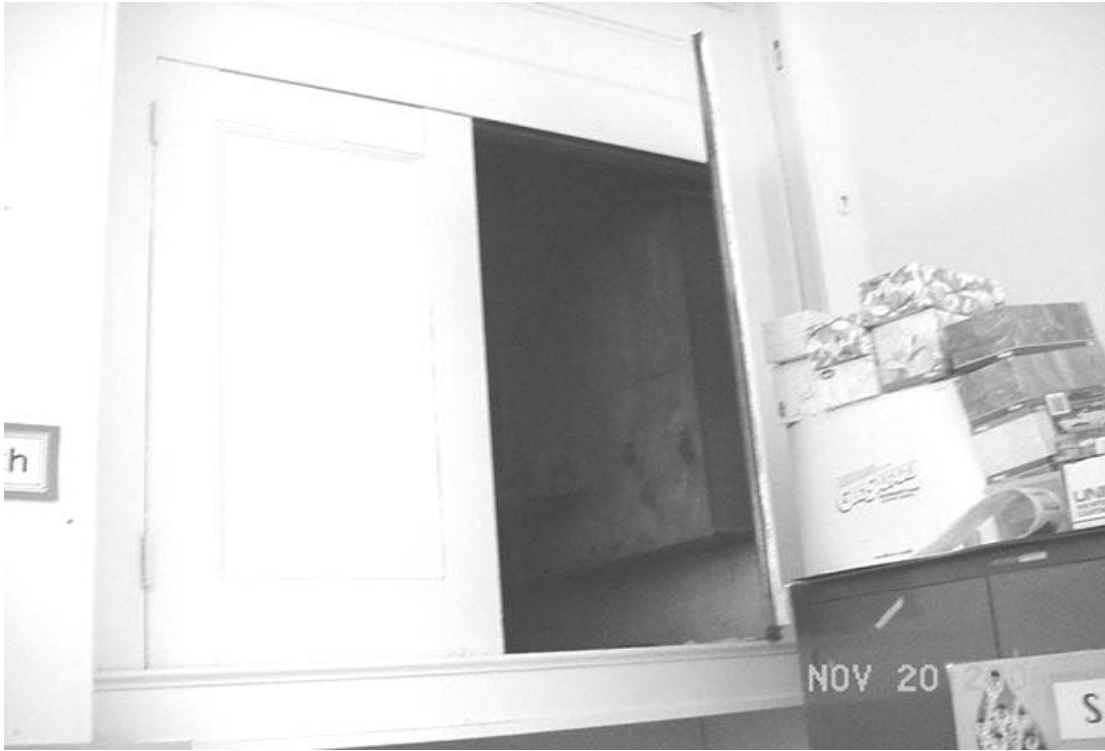
Fresh air in classrooms is supplied by a unit ventilator (univent) system located in a loft between classrooms, which serve as air-mixing rooms (see Pictures 6 & 7).

**Classroom Univent 1920's Wing**

**Access to Univent “Loft” (Air-Mixing Room) between Classrooms**

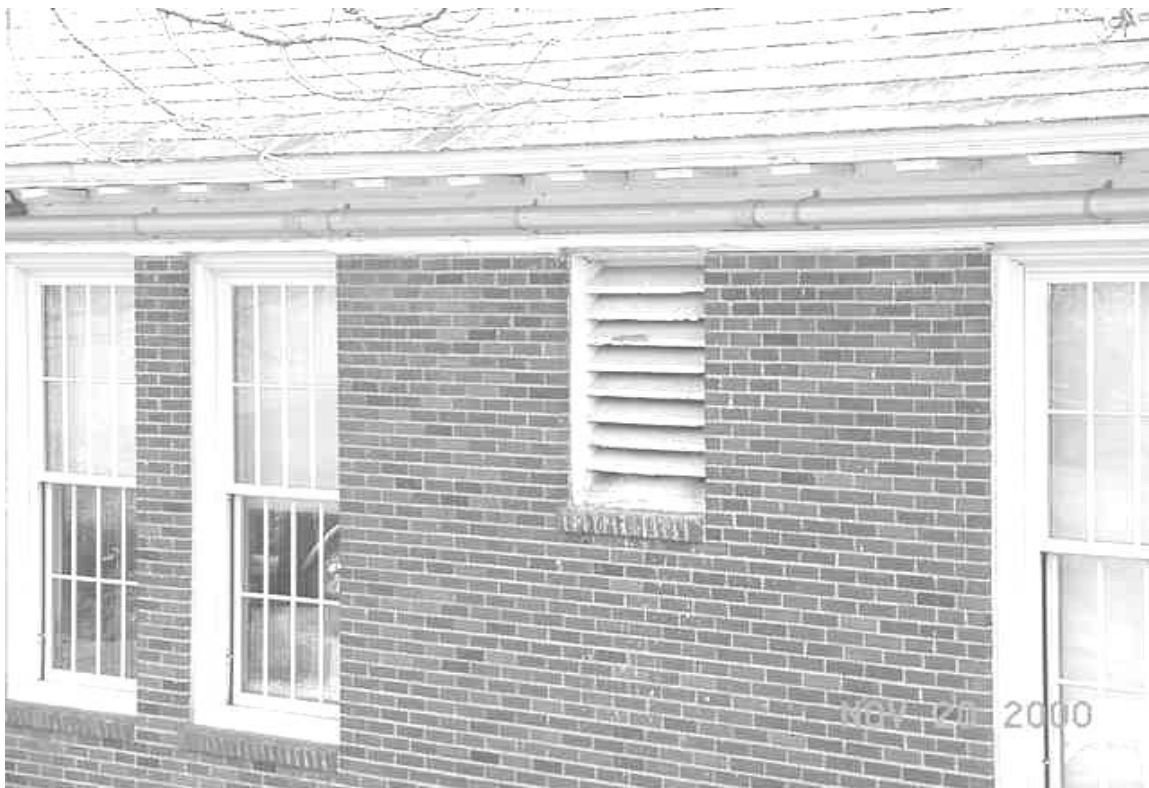
**Picture 8**

Univents are designed to draw air from outdoors through a fresh air intake located on the exterior wall of the building (see Picture 8) and return air through an air intake located at the base of each unit (see Figure 4). Fresh air and return air are mixed, filtered, heated and provided to classrooms through a fresh air diffuser located on the front of the unit.

**Univent Fresh Air Intake 1920's Wing**

2. Once univents are functioning properly, remove obstructions from the univent air intakes, ensure fresh air intake louvers are operable, repair/replace as needed. Install wire mesh or other like material to prevent occupation by birds/pests.

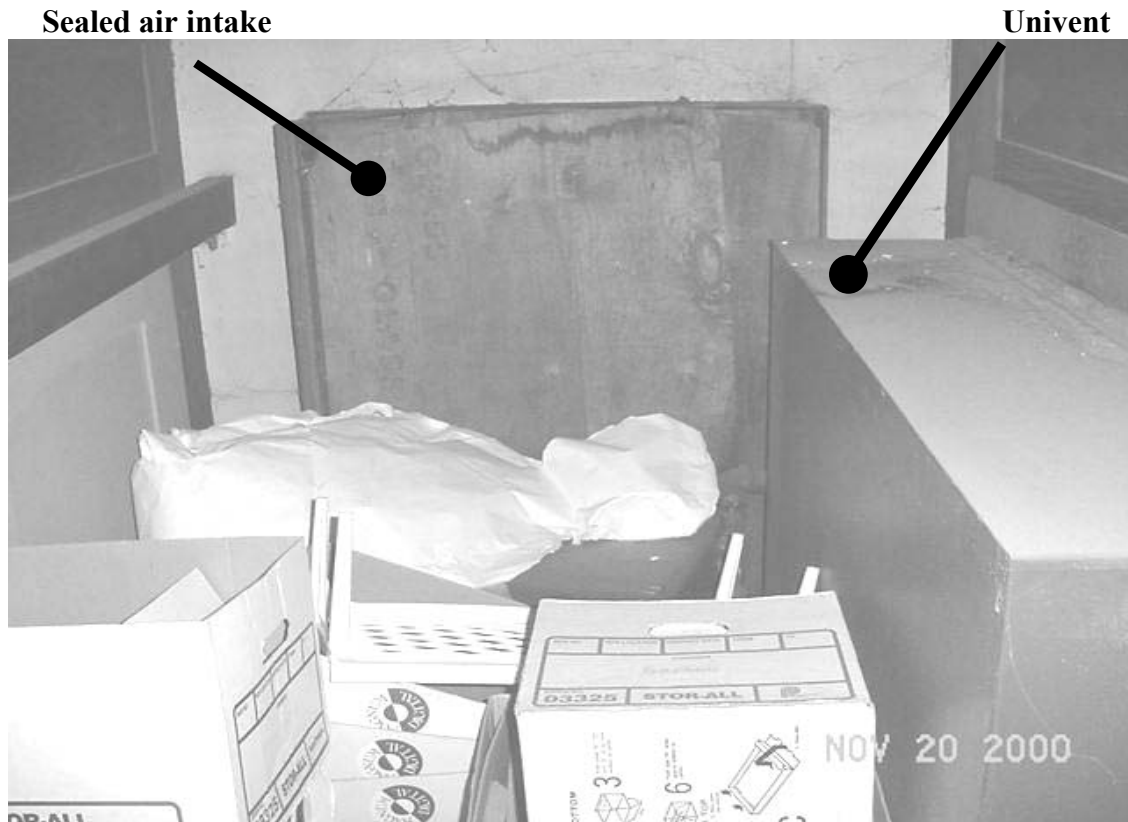
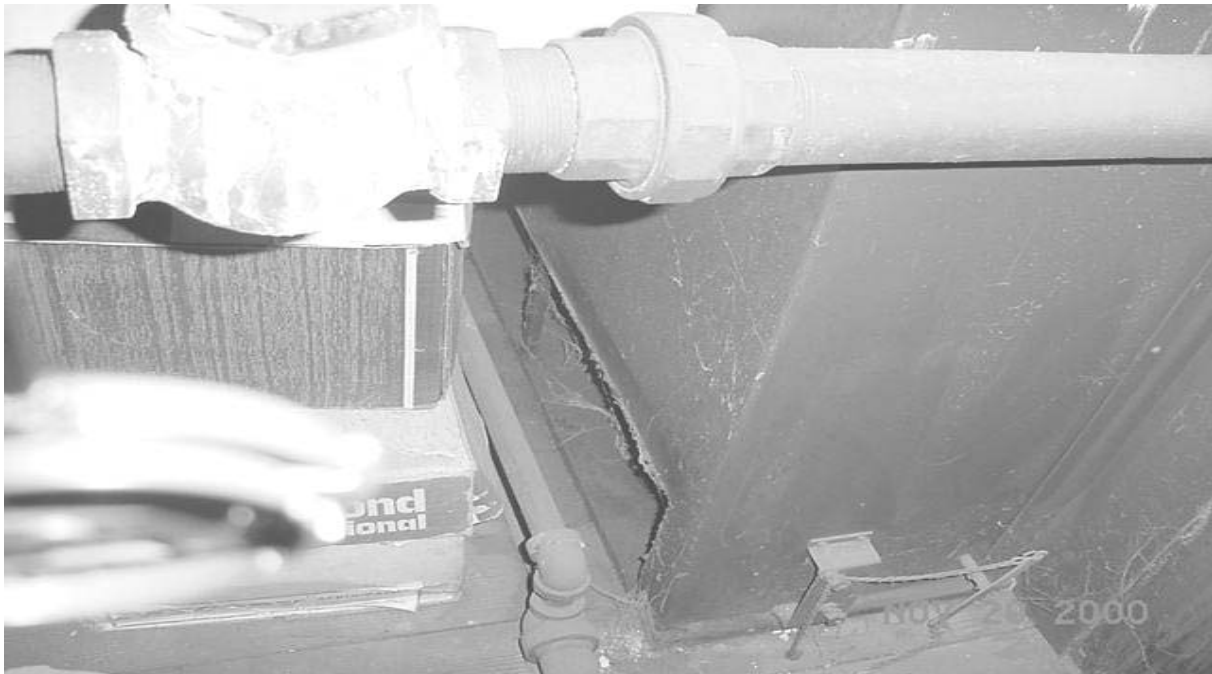
Although univents were radiating heat, none of the fans were operating at the time of the assessment. No fresh air was being mechanically provided to classrooms in these wings, since all outside air intakes were sealed with plywood (see Picture 9), reportedly to keep rodents and pests out. Also noted were a number of materials (e.g., cardboard boxes, plastic totes) stored in these lofts which obstruct airflow to the univents as well as

creating a potential fire hazard due to their close proximity to uninsulated steam pipes (see Pictures 9 & 10). BEHA staff recommended to school personnel that these materials be removed.

**Univent Air Mixing Room Between Classrooms, Note Plywood Sealing Fresh Air Intake and Materials Obstructing Airflow to the Univent**

**Close-up of Univent Air Intake, Steam Pipes and Materials Stored in “Loft” area between Classrooms**

4. Remove all blockages from univents to ensure adequate airflow. Clean out interiors of univents regularly. Remove stored items from univent “loft” areas between classrooms.

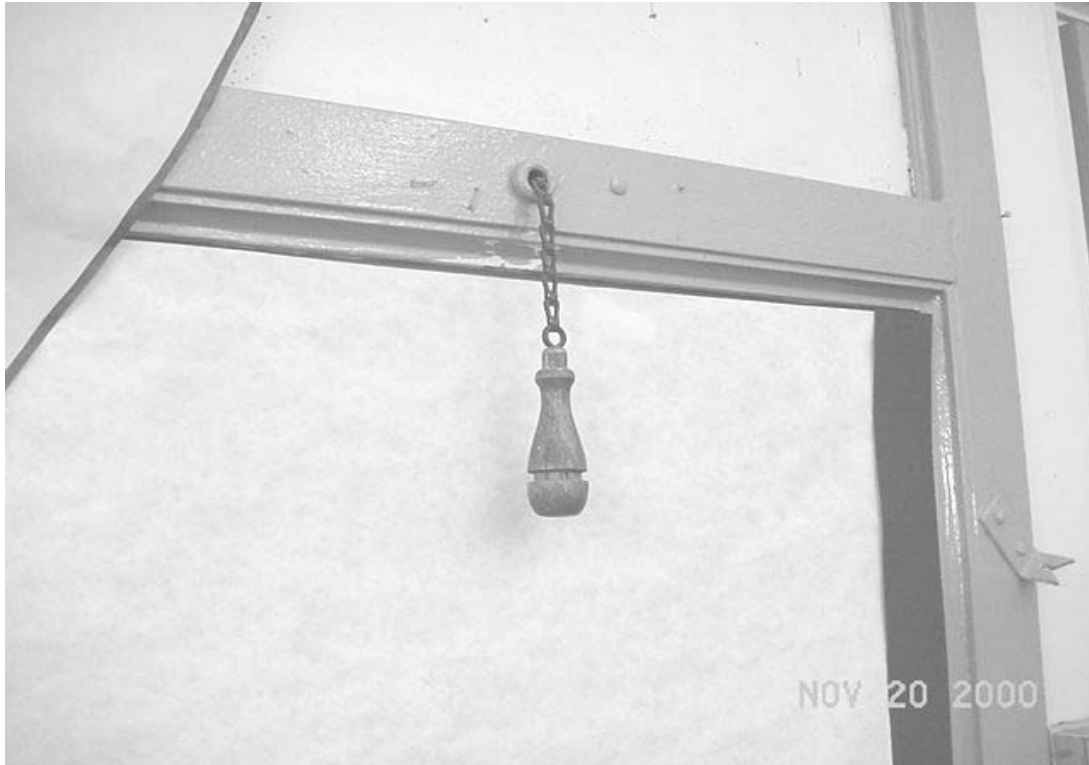
**Picture 11**

Exhaust ventilation for this wing consists of gravity feed exhaust vents located at floor level that are connected by ductwork to sheltered vents on the roof. The draw of air into these cool air vents is controlled by a draw chain pulley system (see Picture 11). Cold drafts were noted from some of the vents (called backdrafting), indicating that the exhaust vents do not operate. Without exhaust ventilation, environmental pollutants can build up in the indoor environment.

**Draw-Chain Pulley System Controlling Exhaust Flue in Classroom**

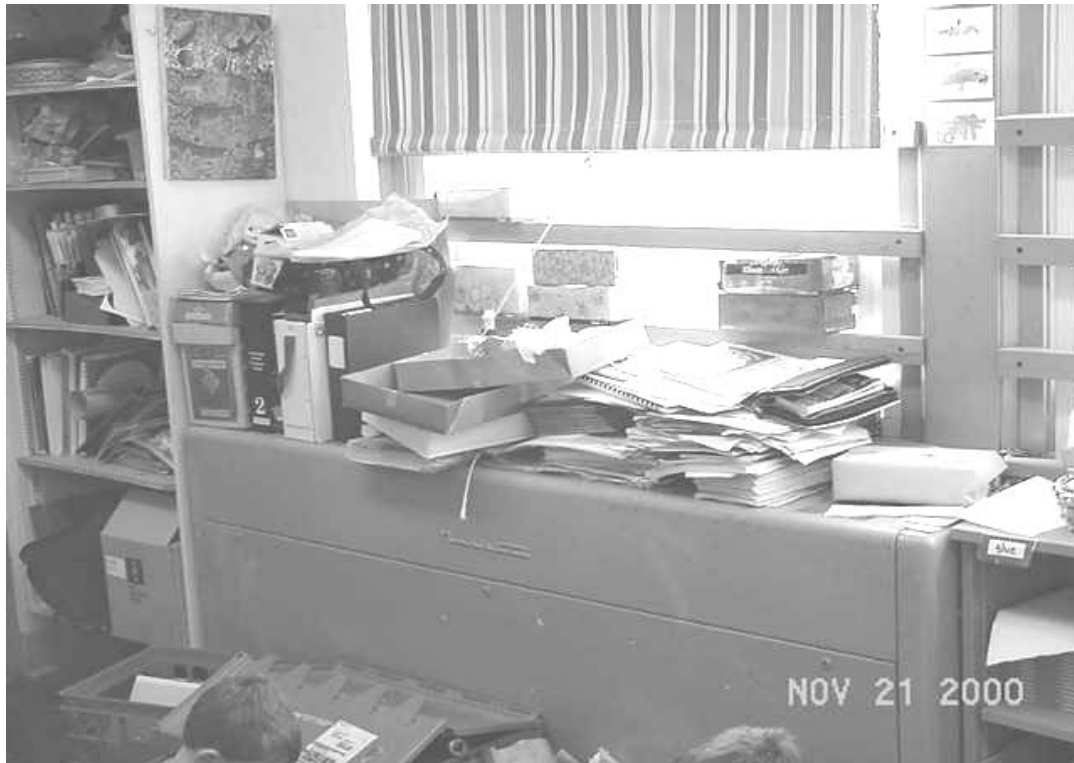
**Picture 12**

Fresh air for classrooms of the 1940's addition is also supplied by a univent system. Univents were found deactivated in many areas. Univents in this wing do not run continuously but are activated by thermostats once room temperatures drop below a set level. When the room temperature exceeds the thermostat setting, univents deactivate. Without mechanical ventilation running continuously, fresh air cannot be introduced into classrooms on a consistent basis. Obstructions to airflow, such as paper and boxes stored on univent air diffusers and desks in front of univent return vents, were also noted in classrooms (see Picture 12). In order for univents to provide fresh air as designed, univent air diffusers and return vents must remain free of obstructions. Importantly, these units must remain activated while classrooms are occupied.

**Classroom Unit Covered with Materials (top) and Return Vent  
Obstructed (front) 1940's Addition**

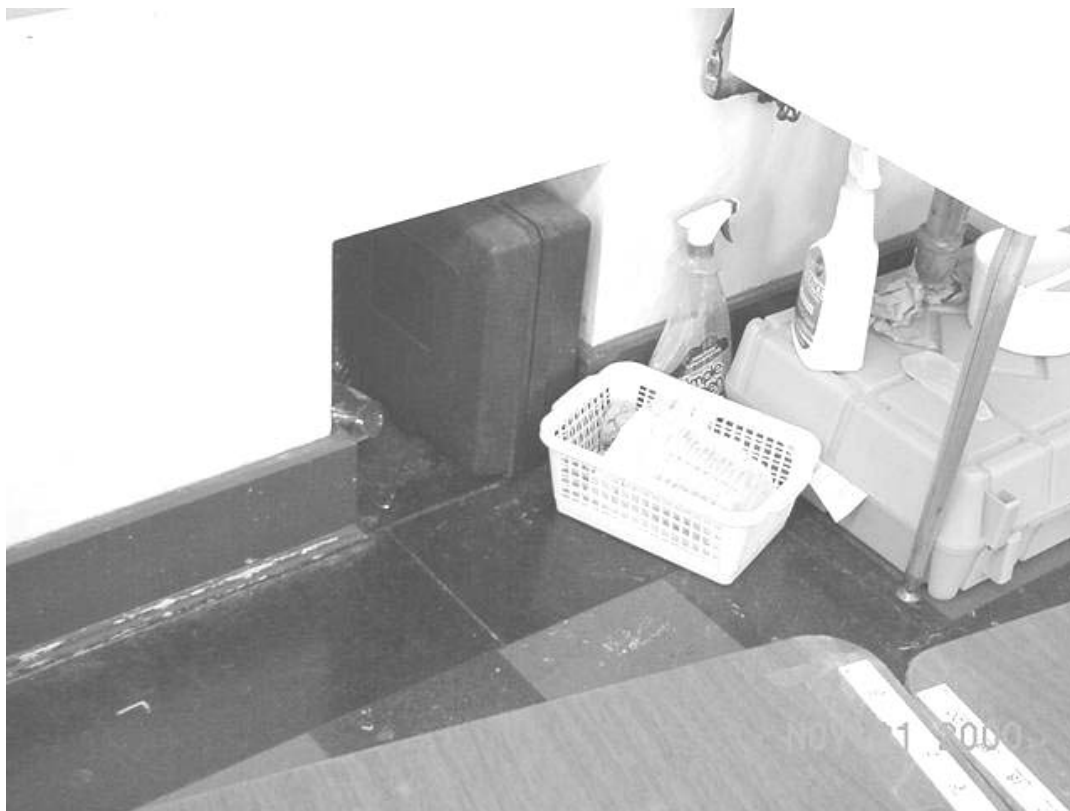
**Picture 13**

Exhaust ventilation is provided by a mechanical system, which draws air into an ungrated hole, located at floor level in classrooms (see Picture 13). Airflow is controlled by a flue located inside the duct. This system appeared to be off in all classrooms

surveyed. Throughout the school these ungrated holes were being used to store recycling bins, crates, books, boxes and files. As with the univents, in order for exhaust ventilation to function as designed, exhaust fans must be activated and remain free of obstructions.

**Exhaust Cubby Filled with Stored Materials**

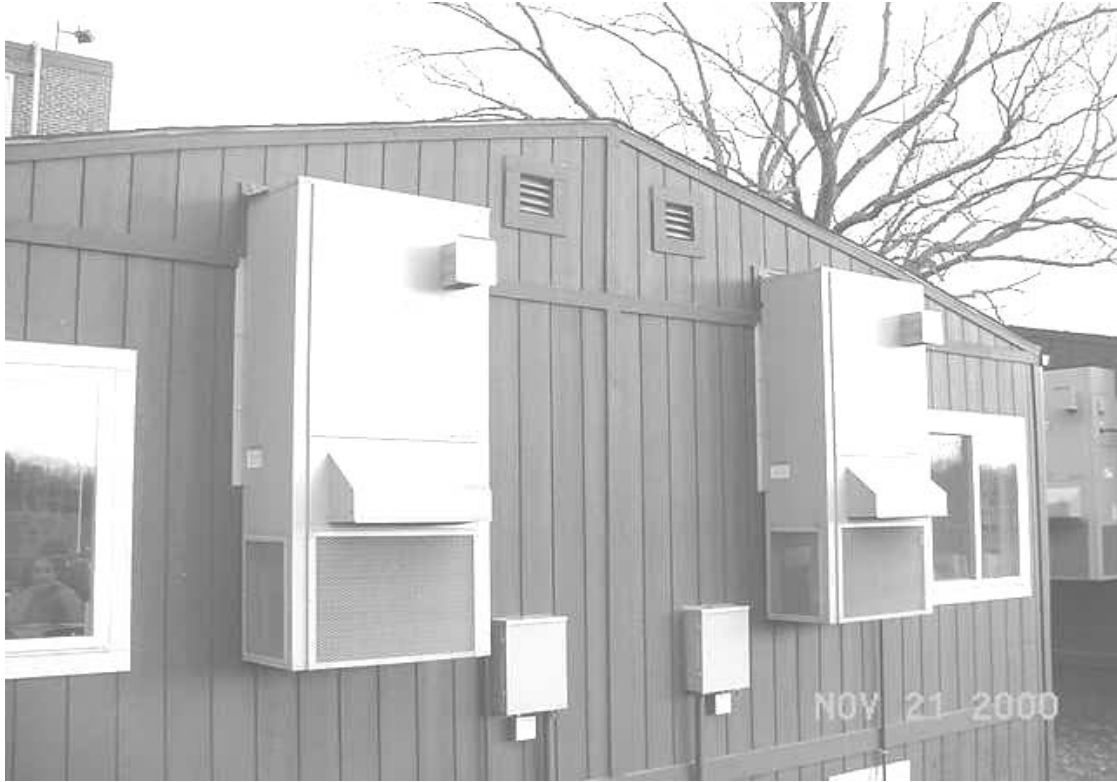
**Picture 14**

The modular classroom wing contains four classrooms. Ventilation for modular classrooms is provided by two ducted air handling units (AHUs) located on the exterior wall of the wing (see Picture 14). Fresh air is distributed to classrooms via ductwork connected to ceiling-mounted air diffusers. The amount of fresh air drawn into the units is controlled by moveable louvers connected to an activator motor that adjusts to alter fresh air intake to maintain temperature. Return vents draw air back to the units through wall or ceiling-mounted grilles. Thermostats control each heating, ventilating and air conditioning (HVAC) system (see Picture 15). In modular classrooms, thermostats have settings of “on” and “automatic”. Thermostats were set to the “automatic” setting in all of the modular rooms surveyed during the assessment. The automatic setting on the thermostat activates the HVAC system at a preset temperature. Once a preset temperature is measured by the thermostat, the HVAC system is deactivated. Therefore no mechanical ventilation is provided until the thermostat re-activates the system.

**Side-Mounted AHU for Modular Classrooms**

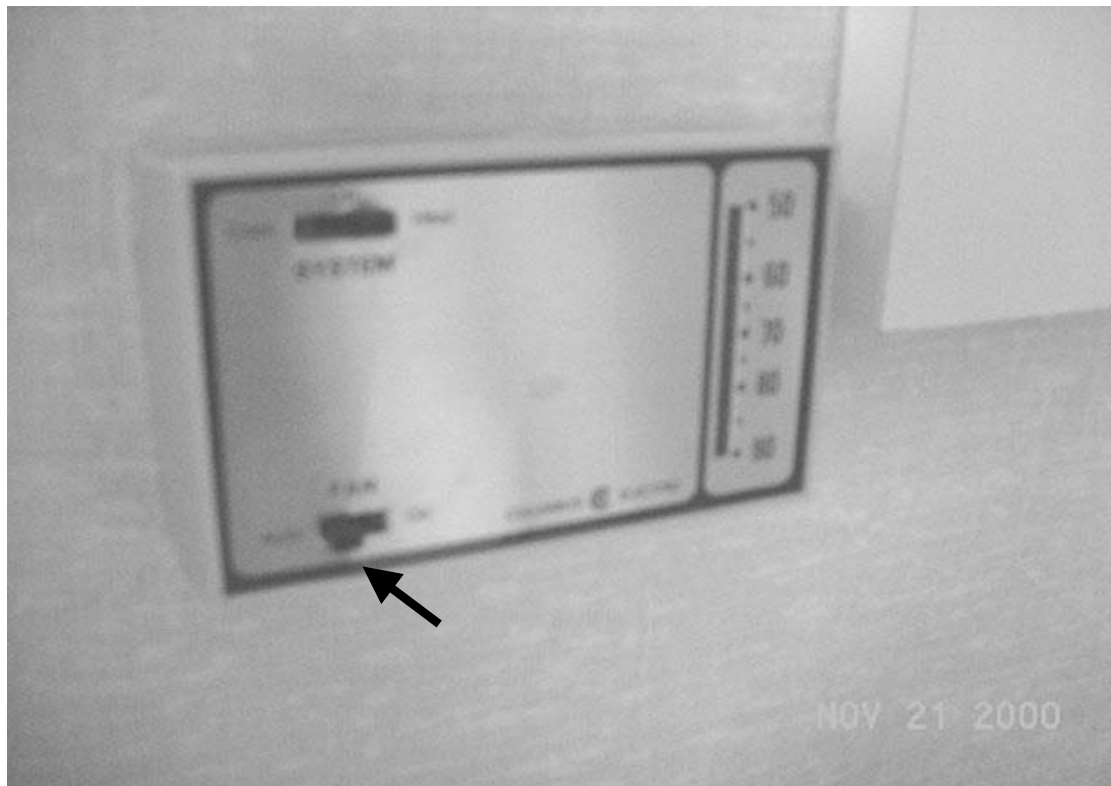
**Picture 15**

**Modular Classroom Thermostat Note Fan Control Switch on “Auto”**

2. Consider setting thermostat controls in modular classrooms to the “on” position to provide constant supply and exhaust ventilation during periods of occupancy.

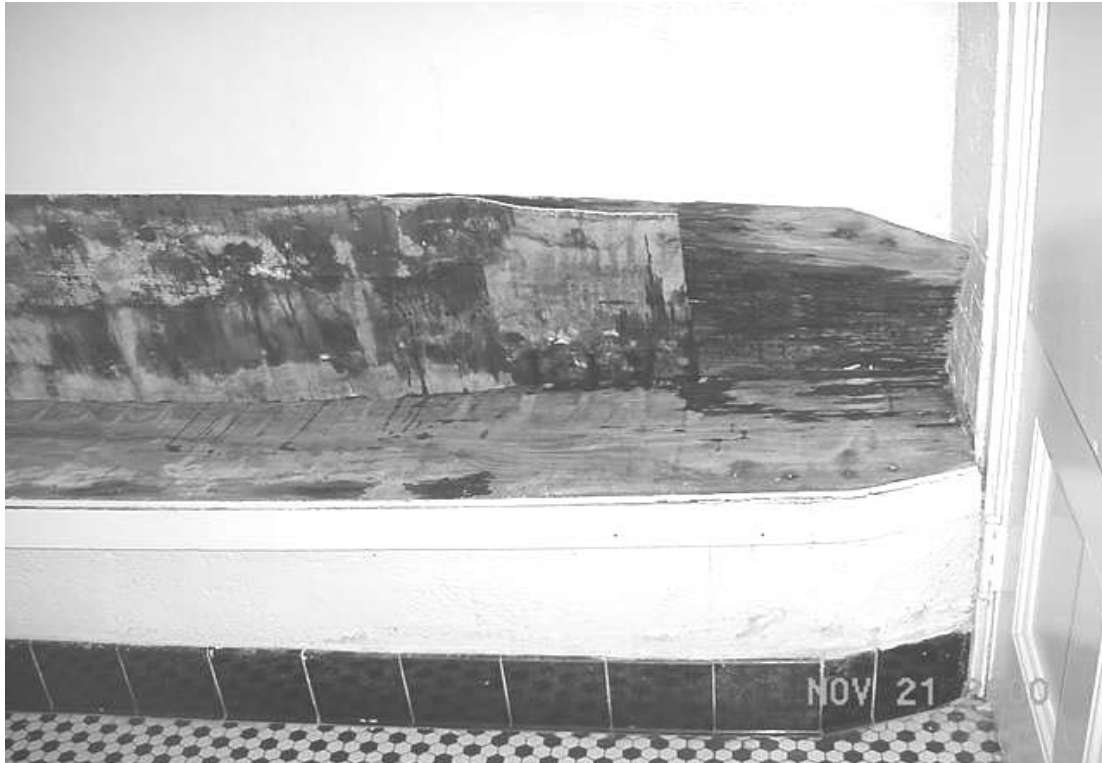
**Picture 16**

A reoccurring steam leak was reported in the girl's restroom in the original building. A steam pipe travels across the rear of this area enclosed in a wood/plaster structure, which also serves as a bench. As a result of reoccurring water damage from the steam leak, the plywood has warped and become colonized with mold growth (see Picture 16).

**Water Damaged/Mold Colonized Wood in Girl's Restroom in Area Where Steam Leak Occurred**

8. Ensure steam leak in girl's restroom is repaired. Replace all water damaged porous materials and disinfect areas with an appropriate antimicrobial as needed.

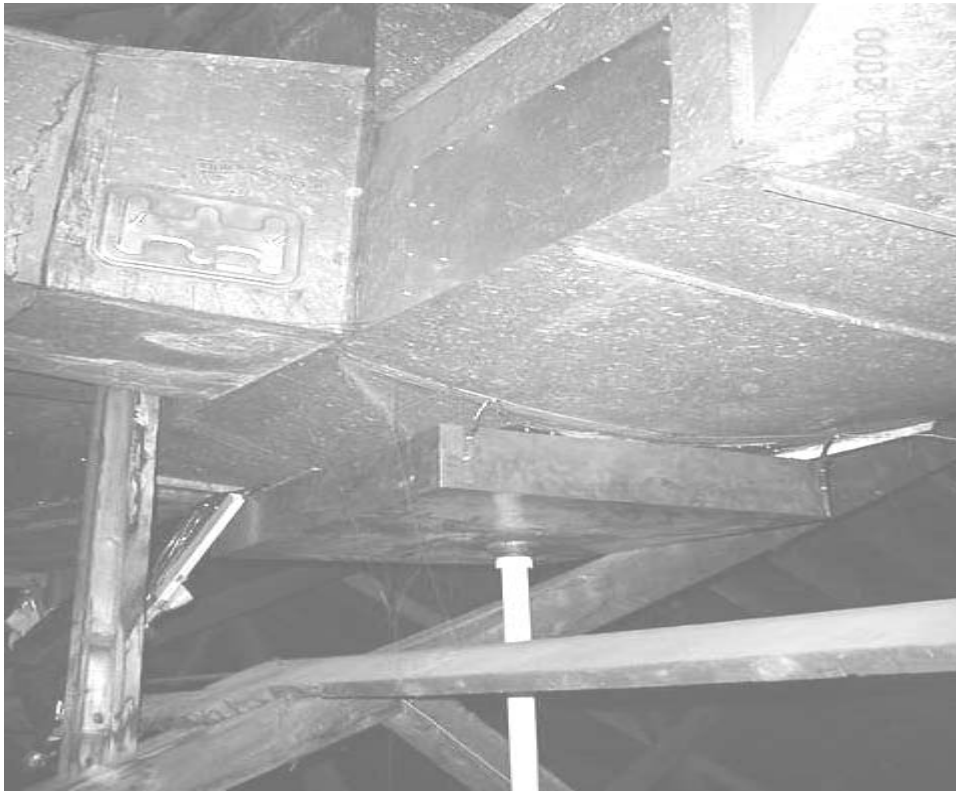
**Picture 17**

Located in the attic was a metal drip pan installed beneath the cupola to catch rainwater. This drain pan is connected to a PVC drainpipe (see Picture 17). School maintenance personnel should ensure that this drainage system installed is properly unclogged and functioning as designed. Several areas had water stained ceiling tiles (see Tables/Picture 18). Water-damaged ceiling tiles can provide a source of mold and mildew and should be replaced after a water leak is discovered and repaired.

**Drip Pan Installed in Attic-Attached to PVC Drainpipe**

11. Examine the cupola drain pan for proper drainage; investigate means to eliminate water penetration into cupola if possible.
  12. Repair/replace loose/broken windowpanes and missing or damaged window caulking building-wide to prevent water penetration through window frames.

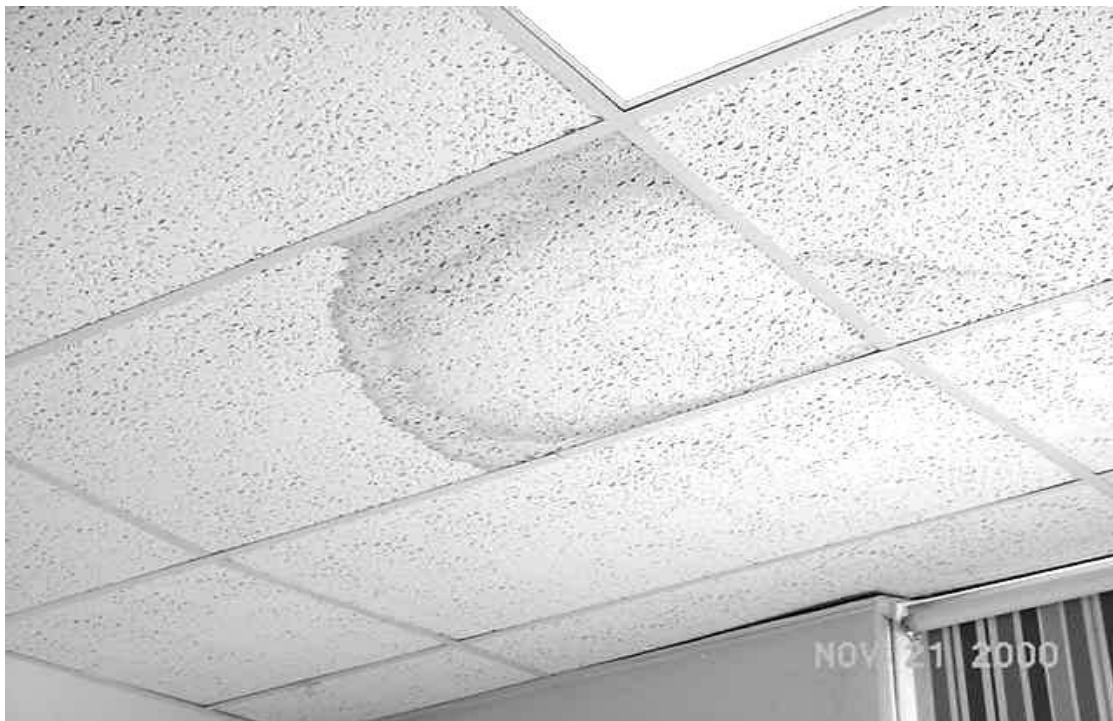
**Picture 18**

**Water Damaged Ceiling Tiles in Classroom**

9. Repair any existing water leaks and replace any remaining water-stained ceiling tiles, wooden flooring and wood trim. Examine the areas above and around these areas for mold growth. Disinfect areas of water leaks with an appropriate antimicrobial as needed.

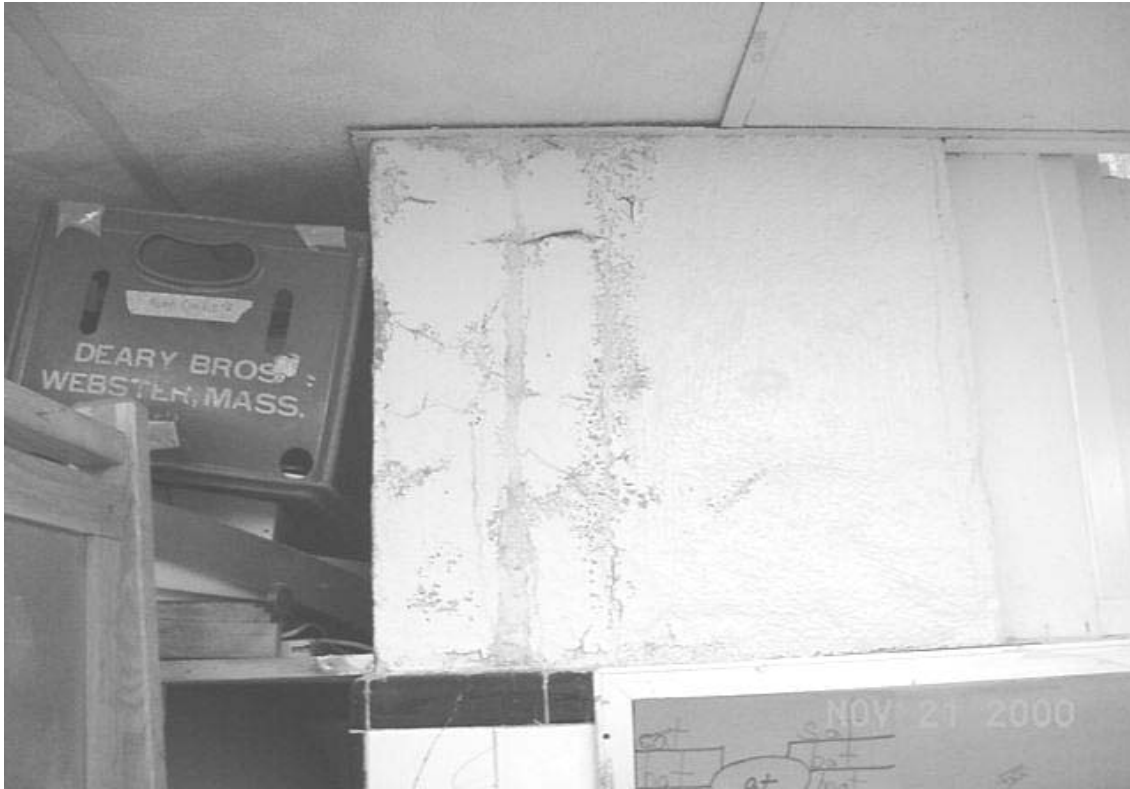
**Picture 19**

Water damaged wall plaster was observed in the resource room located in the basement of the original building, which indicates a current or historic water penetration problem. This room formerly served as a locker room/shower area, which was renovated

into a resource room. Efflorescence (i.e., mineral deposits) was observed on the interior walls of the room (see Picture 19). Efflorescence is a characteristic sign of water intrusion. As moisture penetrates and works its way through mortar around brick it leaves behind these characteristic mineral deposits. This condition indicates that water from the exterior is penetrating into the building. The area is also carpeted. Water damaged materials such as wall plaster and carpeting can serve as a medium to support mold growth. A broken window was noted in the gymnasium and the window and windowsill in the speech room was wet with moisture (see Picture 20). Broken windows can provide a source of water penetration into the building, which can subsequently lead to damaged building materials and mold growth. The speech room is carpeted and not equipped with mechanical exhaust ventilation, which could help remove heat and moisture. When warm, moist air passes over a surface that is colder than the air, water condensation can collect on the cold surface. Over time, water droplets can form, which can then drip from a suspended surface. The cool temperature of the windowpanes would make them prone to generating condensation. Dripping condensation can lead to mold growth on porous materials (e.g., items stored on windowsills, carpeting). As mentioned previously, water-damaged carpeting cannot be adequately cleaned to remove mold growth.

**Water Damaged Wall Plaster in Resource Room (Former Shower Area)**

10. Consider having exterior brick repointed and waterproofed to prevent further water intrusion. Repair/replace water damaged plaster. Examine surrounding non-porous areas for mold growth and disinfect with an appropriate antimicrobial if necessary.

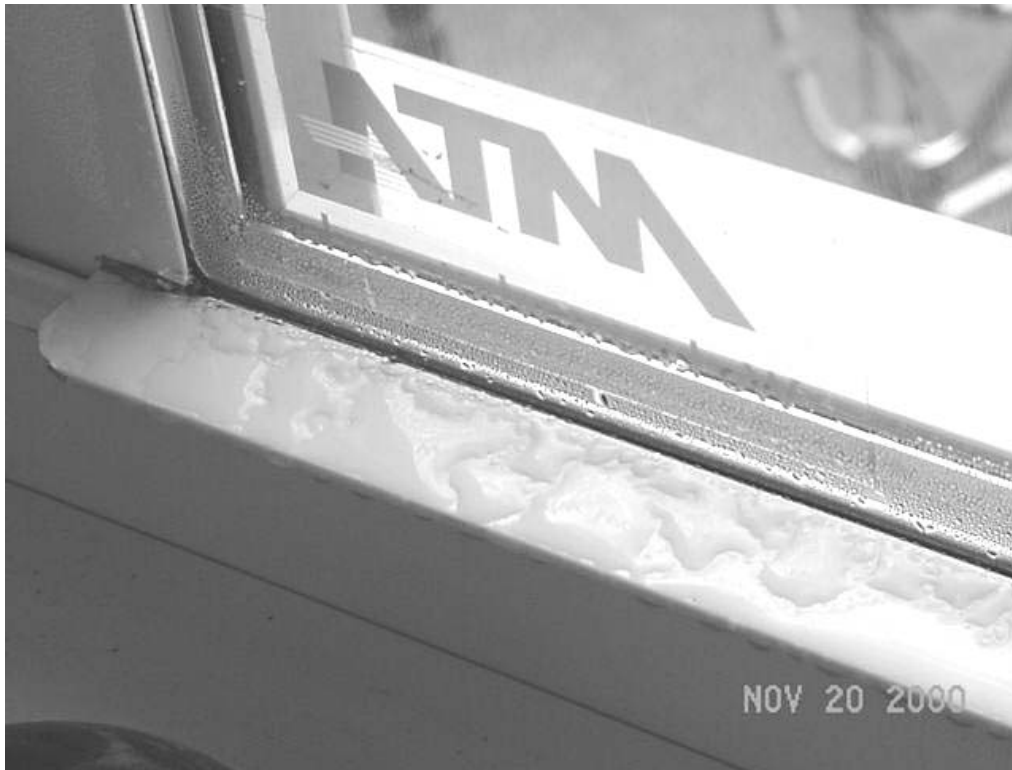
**Picture 20**

**Condensation on Wooden Windowsill in the Speech Room**

5. Consider installing a local exhaust vent to help remove moisture and condensation in the speech room. Locate exhaust ventilation in cafeteria.
6. Consider reducing the heat load in the councilor's office by installing a smaller radiator more proportionate to the room size and occupancy.
7. Examine the feasibility of installing a heating, ventilating and air conditioning system in the computer room to circulate air and reduce heat load generated by computers and related equipment.

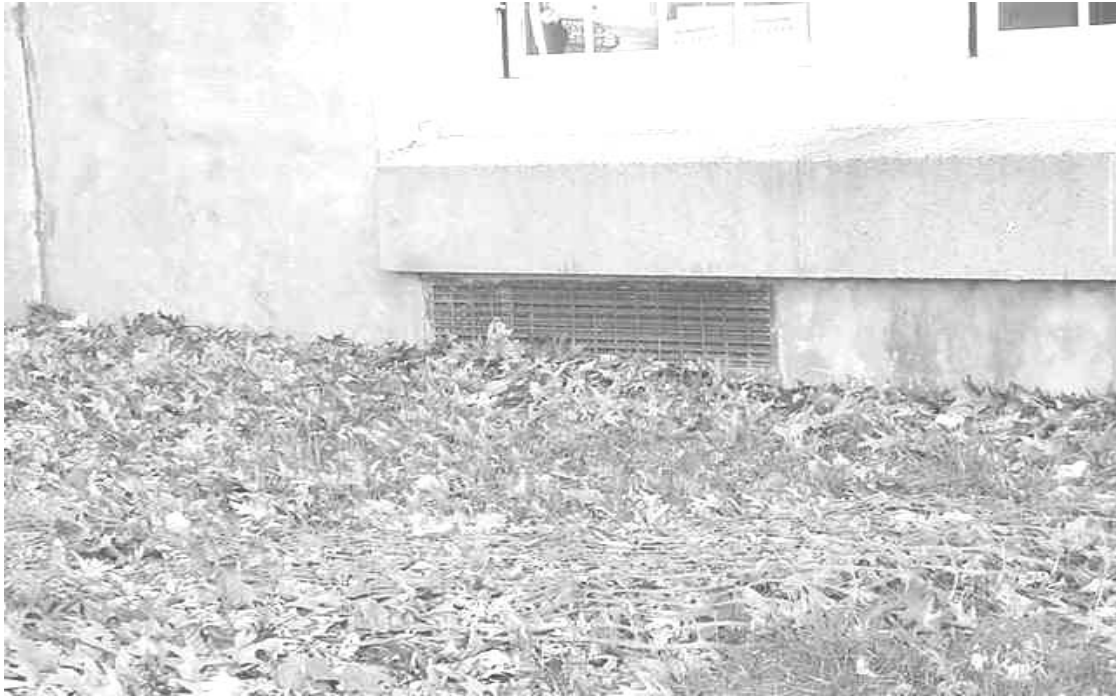
**Picture 21**

Along the perimeter of the building, some of the univent fresh air intakes are located at ground level, which makes them prone to be covered with snow (see Picture 21). Care should be taken to ensure that fresh air intakes remain clear of obstructions (e.g., snow, shrubbery) to avoid the entrainment of dirt, moisture and or pollen. Also, roof drain strainers were noted clogged with debris (see Picture 22). This can result in pooling water, which can cause drain spouts to back up and overflow. These conditions undermine the integrity of the roof system and may be an indirect source of water penetration into classrooms.

**Univent Fresh Air Intake at Ground Level**

15. Ensure that snowdrifts are cleared from univent fresh air intakes during periods of heavy snowfall.

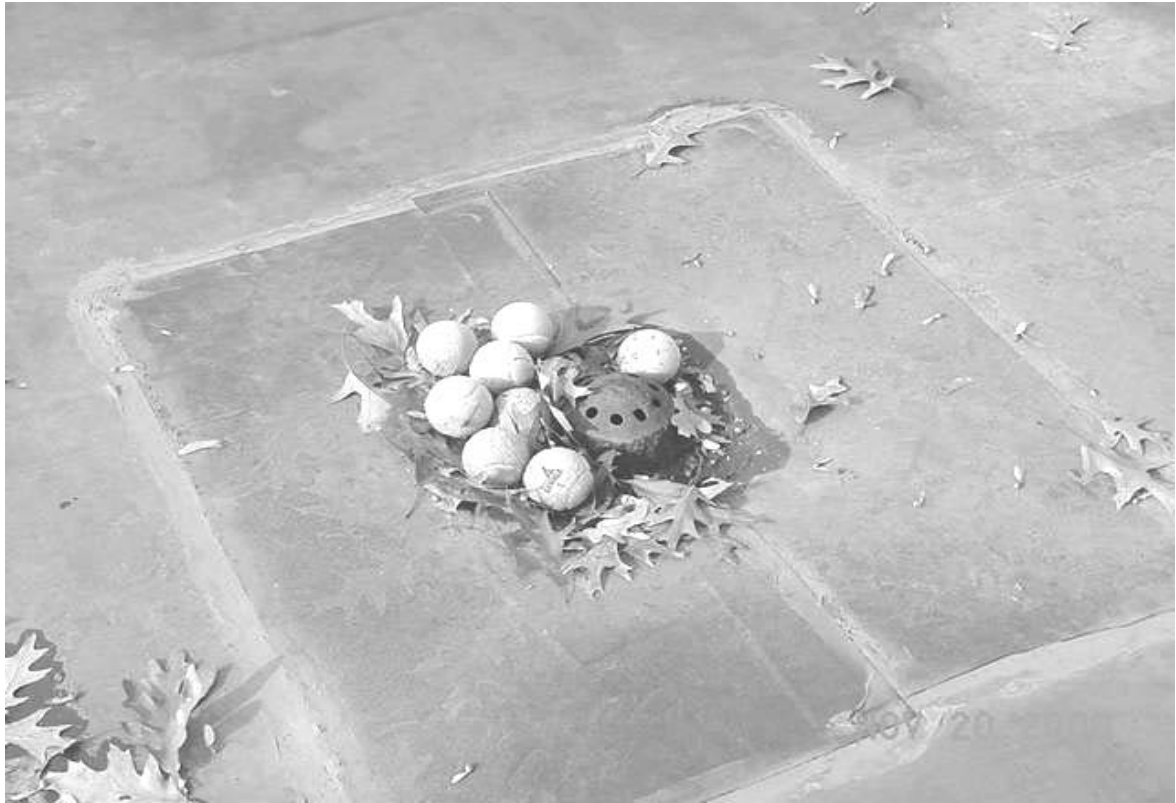
**Picture 22**

**Roof Drain**
